PHASE 1 INSPECTION REPORT
NATIONAL DAM SAFETY PROGRAM.

Bethany New City Reservoir Dam (MO 10071),
Missouri - Grand - Chariton Basin,
Harrison County, Missouri. Phase I Inspection
Report.

Name of Dam	Bethany New City Reservoir Dam
State Located	Missouri
County Located	Harrison County
Stream	Tributary to West Fork of Big Creek
Date of Inspection	July 20, 1978

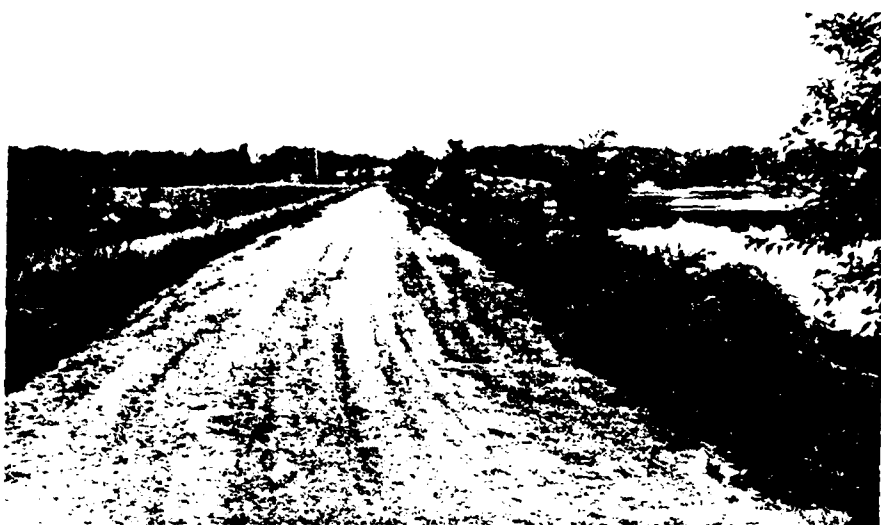
The crest of the dam is covered with road gravel and is well maintained. No cracks or abnormal deformations were noted on the crest. The downstream slope is well vegetated with alfalfa or vetch, brome and other grasses. It appeared to have been mowed quite recently. There were no indications of seepage, slides or deformations on the downstream slope or along the downstream toe. The drain outlet on the left (east) side of the downstream slope was discharging a bare trickle of clear water. There was no indication that the drain outlets have ever discharged very much water. Both abutments consist of stiff, silty clays (CL or CH) overlying alternate beds of limestone and shale. Some of the shale members (as exposed in the spillway channel) are indurated and almost fissile. No slides, seeps or deformations were noted in the abutments.

PHOTO NO. 2
TOP OF DAM.
LOOKING WEST
FROM EAST END.

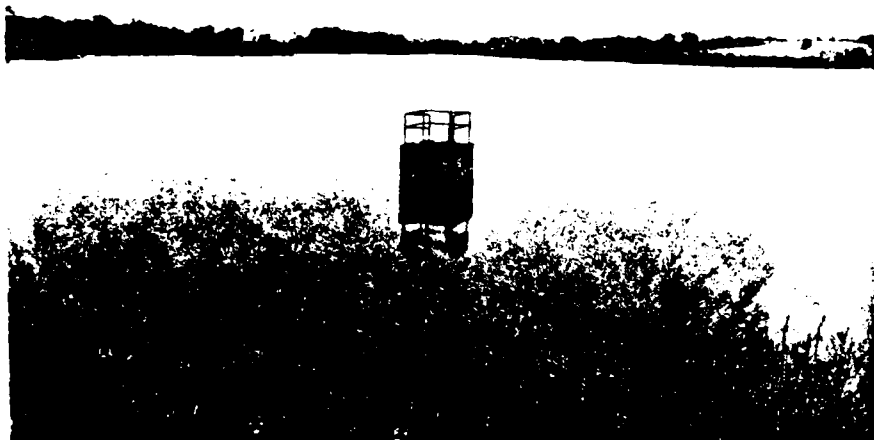
The concrete gate tower looked good and it is assumed that all valves and gates are operable since this reservoir supplies water to the City of Bethany.

PHOTO NO. 5
GATE TOWER FROM
CENTERLINE OF
DAM LOOKING
UPSTREAM.

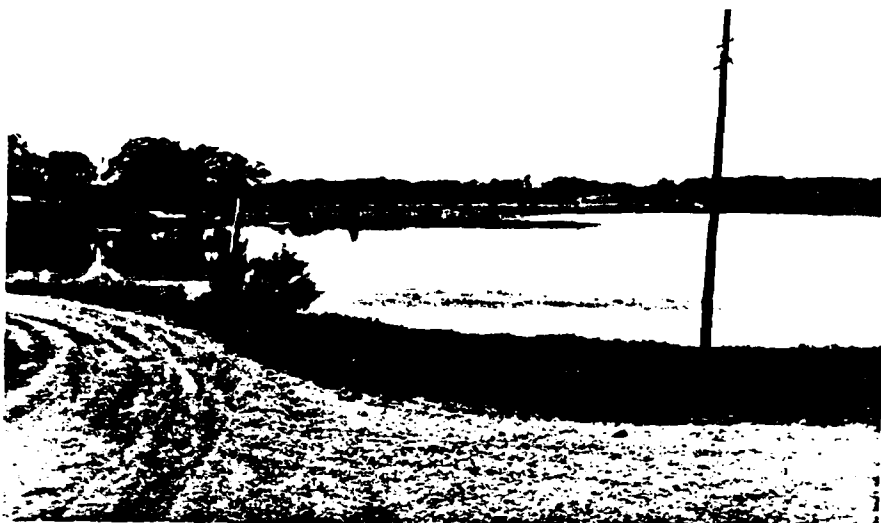
PHOTO. NO. 8
OVERVIEW FROM
ROAD ENTRANCE
ON EAST SIDE
OF LAKE.
